# Formation of Waterside Spaces with Groins

<b>Title</b>	Formation of Waterside Spaces with Groins
<b>Author</b>	FUKUSHIMA, Yasumasa / UCHIDA, Takashi
<b>Citation</b>	Memoirs of the Faculty of Engineering Osaka City University. Vol.55, pp.27-33.
<b>Issue Date</b>	2014-12
<b>ISSN</b>	0078-6659
<b>Type</b>	Departmental Bulletin Paper
<b>Textversion</b>	Publisher
<b>Publisher</b>	Graduate school of Engineering, Osaka City University
<b>Description</b>

Yasumasa FUKUSHIMA\* and Takashi UCHIDA\*\*

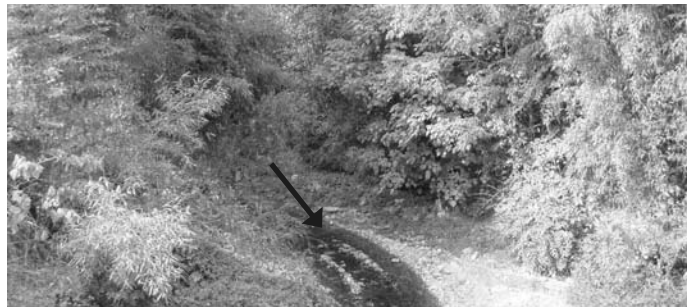
Nature-friendly river works were advanced on the Yoshiminegawa River of the class-A Yodogawa River system. At the river bend (Fig. 3), which is a planning site, establishment of a land–water ecotone was advanced for creating waterside utilization or a habitat of a good ecosystem on the inner bank. At the same time, policies for protecting river banks were required while creating deep water in the water colliding front incorporated with low-water bed works by crosspiece structures on the upper and lower streams.

Fig. 3 View before construction (Case 3).
